Rettysnitch Corner: When good enough just isn't … Part II

(Signalink USB® Mods)

Mat Breton - AB8VJ

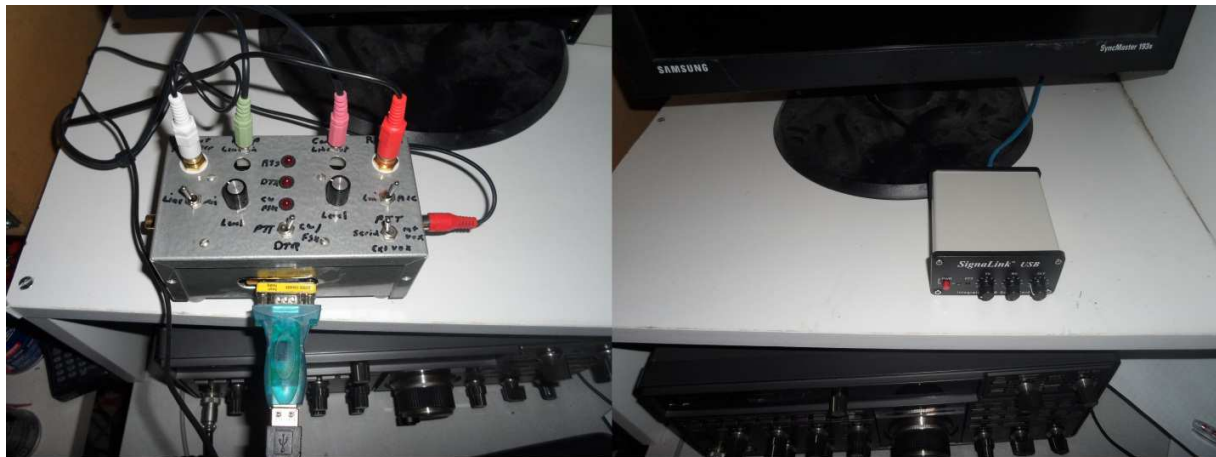
(A) Homemade Interface   (B) Signalink USB Interface

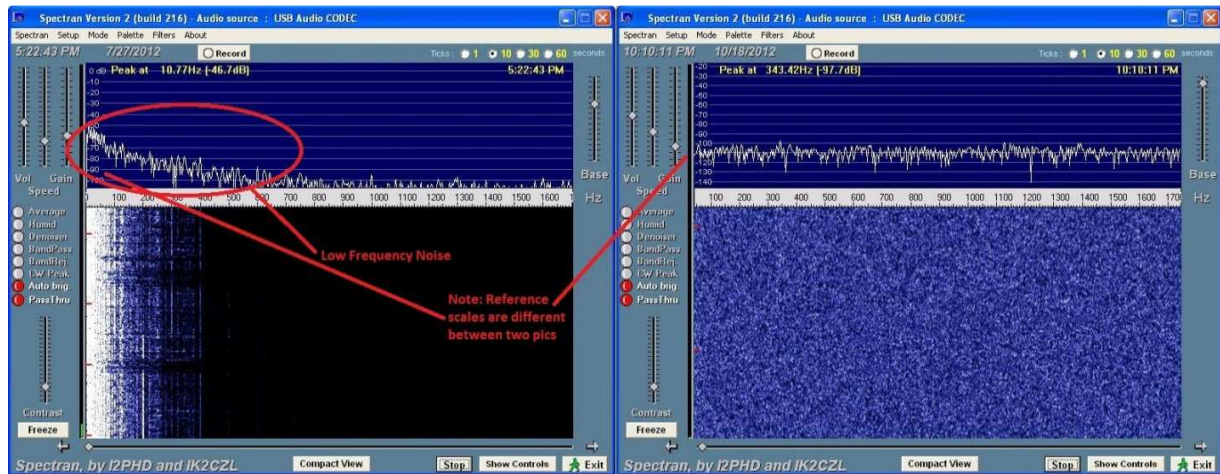
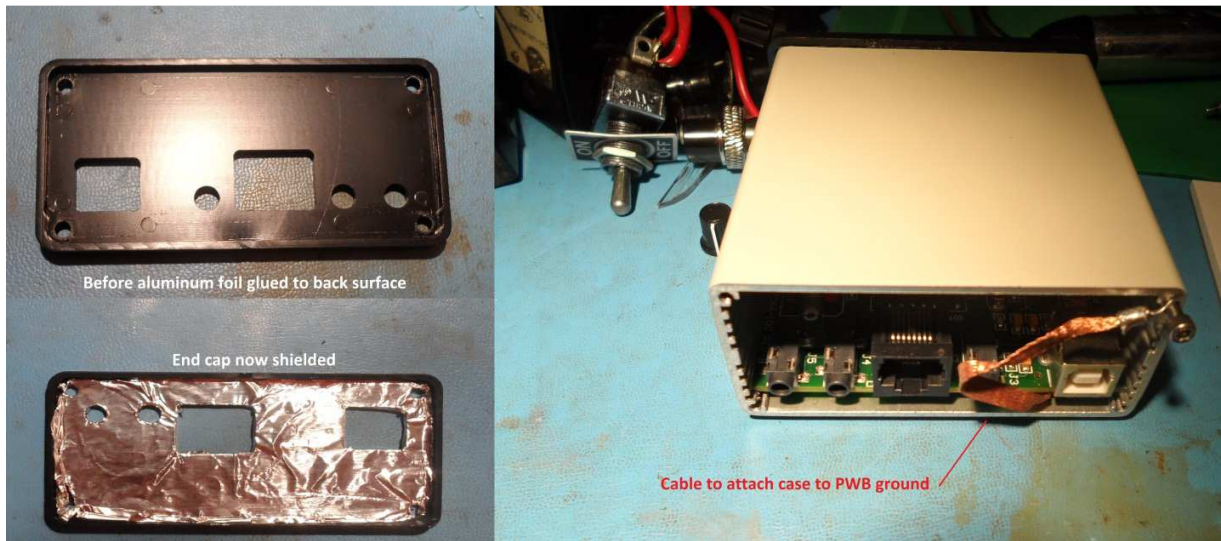
(A) Noise Floor Before Mod   (B) Noise Floor After Mod

When I got it home, the first thing I did was hook it up to verify basic operation: great, it worked. I also verified that the computer and rig truly were galvanically isolated (many of its competition are not). But I'm not satisfied with "it seems to work" … I need to know how well it works. Using a second laptop as a sound generator, and using analyzer software on the primary computer, I ran it through some basic tests. Its frequency response from 50Hz to 3kHz was relatively flat (within 3dB) across a wide input dynamic range on both receive and send. Unfortunately I discovered that it had significant (50dB) low-

frequency broadband noise (between 10Hz and 700Hz; the noise peaked at about 100Hz, and followed an approximate 1/f curve). 50dB is huge: more than a 300 times the electrical noise at low frequencies. There were also a couple of other quirks (less critical but interesting and/or annoying): when the device was turned off it continue to send sound to the computer, but at a 10 to 15dB reduced level. Also, when the device was turned off it generated a 30dB noise spike at approximately 1 kHz (and even harmonics). In my opinion, while the device was functional it didn't meet my high expectations.

- The bias circuits for the op-amps were directly driven from the USB power, with only some minor capacitive decoupling: This resulted in an extremely low circuit PSRR (Power Supply Rejection Ratio) in spite of the low-noise high-PSRR op-amps used in the design, with the noise from the USB power feeding directly into the audio stream.

The most important modification involves removal of the internal electrical noise. There are several well-known ways to buffer the bias op-amp bias voltage from the noisy 5V-USB line: insert an op-amp unity gain amp, install a massive decoupling network, use a voltage tracker or voltage regulator, etc. I chose to use regulated supply … because there is already an on-board low-noise supply at 3.7V for the comparator in the PIC microcontroller and the Audio USB IC A/D reference. I only had to add one jumper and replace one resistor (to put the bias back at 2.5V), and the noise was gone. This solution only cost $0.02. The figure below shows the before (a) and after (b) results.
